THE BOUSH CREEK DRAINAGE PROBLEM AT NORFOLK, VIRGINIA

By PERRY W. RUTH, Chief of Bureau
Mosquito Control, Norfolk, Virginia

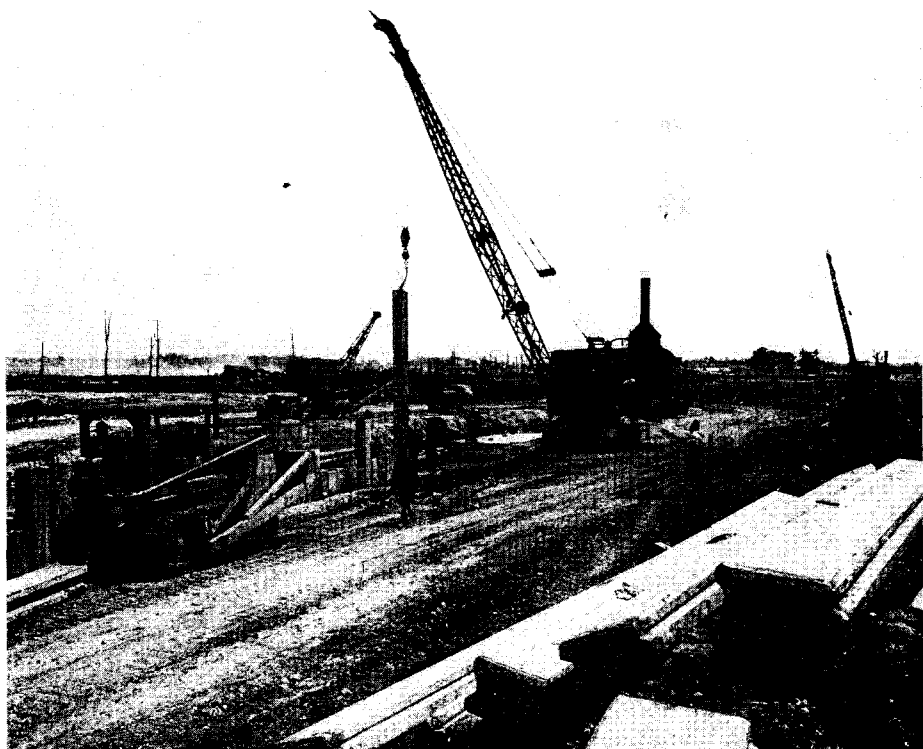
Fig. 1. Navy Drainage Project for Elimination of Mosquito Hazard, Boush Creek, Norfolk, Virginia. Placing and driving piling for 1,400 feet of 24 foot canal through an area of hydraulic fill.

The side walls of this canal were created by driving parallel lines of continuous tongue-and-groove reinforced concrete sheet piling down through the hydraulic fill into the old marsh floor below, the lines being 24 feet apart. (See cut No. 1) On account of the deep fluid mud overlaying the firm material, it was first necessary to drive the wooden piles which would support the flume bottom, providing sufficient

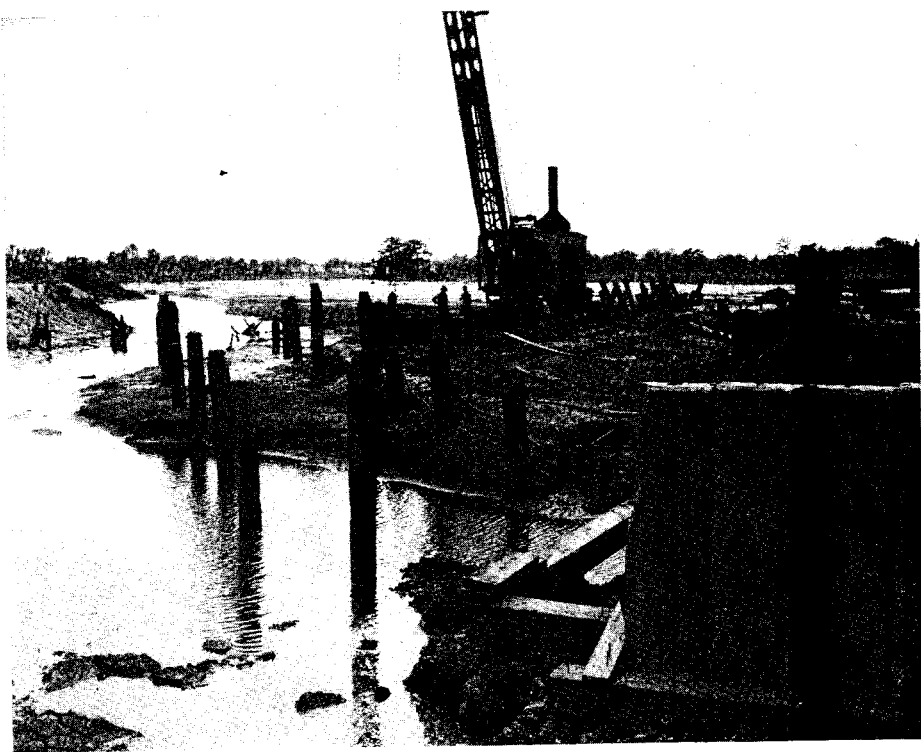
Fig. 2. Navy Drainage Project for Elimination of Mosquito Hazard, Boush Creek, Norfolk, Virginia. Intake end of 24 foot canal. Two lines of wooden piling will be cut off to carry reinforcements for concrete floor while cross piling near machine will brace wing-wall.

additional length so that their tops would temporarily project above the marsh and support a template for setting and bracing the two lines of concrete sheet piling, as is shown in cut No. 2 where the canal is emerging into the impounded water area. After the concrete sheeting was in place, the mud between the walls was excavated by bucket and removed with Euclid bottom dump trucks. (See cut No. 3) The wooden piles were then cut off to grade and the reinforced concrete bottom installed in the canal or flume, the timber template and additional timber bracing temporarily supporting the walls against the external pressure of the mud. After the floor was poured and set, the timbering was removed, a concrete coping was installed on each of the walls and an open 24 foot canal remained. Piped side openings were left at certain places to care for drainage from various areas brought in by ditches

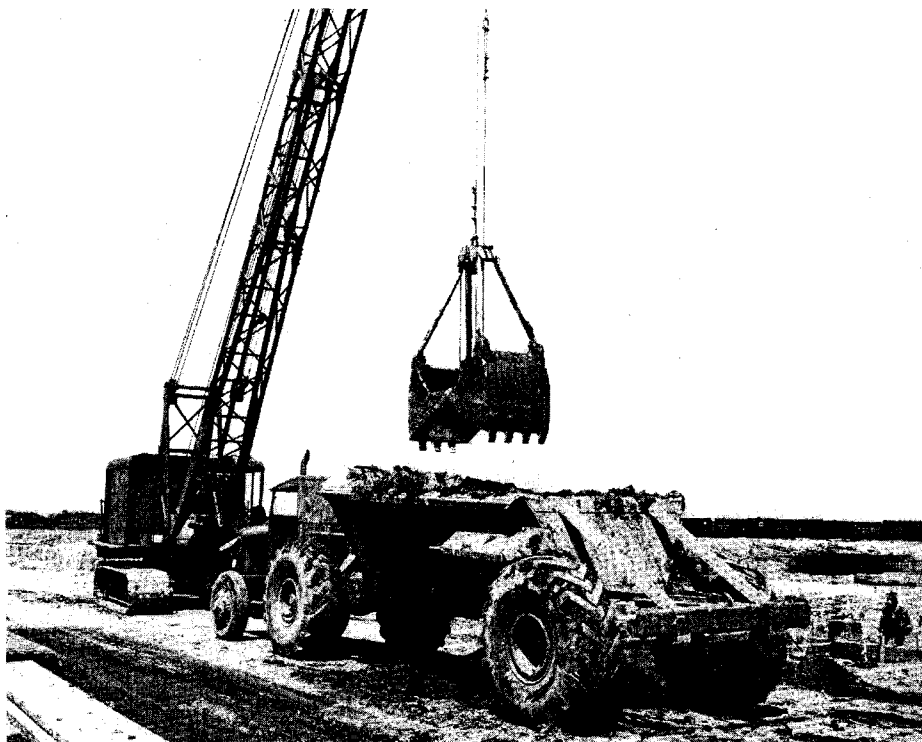
Fig. 3. Navy Drainage Project for Elimination of Mosquito Hazard, Bousch Creek, Norfolk, Virginia. Material between sheet pile walls of canal is excavated by bucket-crane and removed by heavy duty "bottom dump." Concrete floor of canal is then poured to grade and wooden bracing removed.

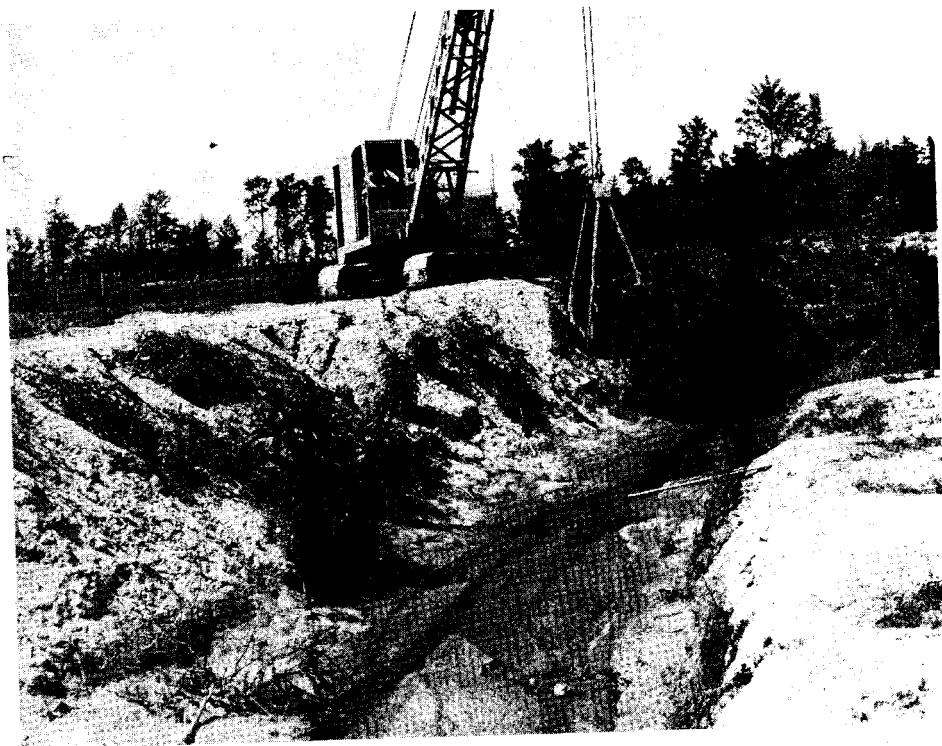
Fig. 4. Navy Drainage Project for Elimination of Mosquito Hazard, Boush Creek, Norfolk, Virginia. Several ditches, like the one being reconditioned here with a bucket-crane, will carry surface run-off to piped openings in the side walls of the 24 foot canal.

such as the one shown being reconditioned in cut No. 4.
