NOTES ON MALARIA CONTROL IN MANAGUA, NICARAGUA

CLARENCE I. STERLING

Chief Engineer and Assistant Director, Health and Sanitation Division,
Institute of Inter-American Affairs

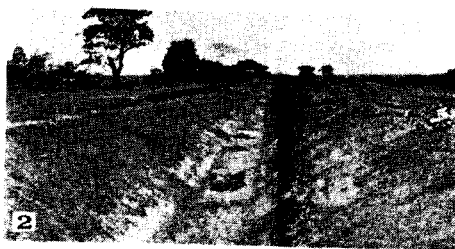
FIG. 2. Diversion ditch taking form.

The western section of Managua was drained ineffectively by a large, open ditch, called the Cauce Occidental, which had been built in 1890. This ditch followed a northwesterly direction skirting the city limits and discharged directly into Lake Managua. It intersected and drained surface run-off from all principal streets. In the fifty years since its construction, the Cauce Occidental had received little maintenance and at many points the channel was obstructed or seriously damaged. The problem was therefore one of restoration. The project included cleaning and regrading of 11,034 lineal feet of channel, construction of 3 rubble-masonry drops for grade reduction, and building two large concrete arch culverts [88 feet long]. Beginning work in March, the project was finished in June, 1943.

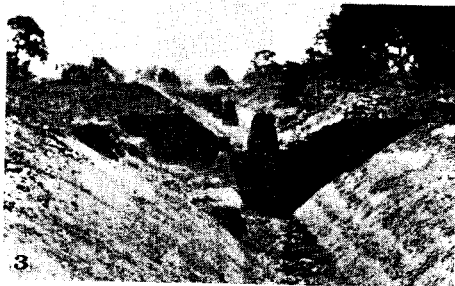
FIG. 3. One of the 17 drops along "Cauce Oriental."

in 1942 by the Sanidad and the Institute of Inter-American Affairs showed the prevalence to be consistently higher in the eastern end of the city. Construction of another large ditch, Cauce Oriental, to drain storm waters into the lake from the settled region was begun in November, 1942, and completed in August, 1943. The original design was drawn by Magoon in 1933, modified by Lowe in 1935, and again modified by the Institute of Inter-American Affairs in 1942. The ditch was built 13,800 feet in length, trapezoidal in shape with the longer side at the top. An interesting feature in its construction is the use of 19 massive concrete drops, four to twelve feet in height, along the course of the channel. The hydraulic capacity of the Cauce Oriental is more than 1,000 cubic feet per second

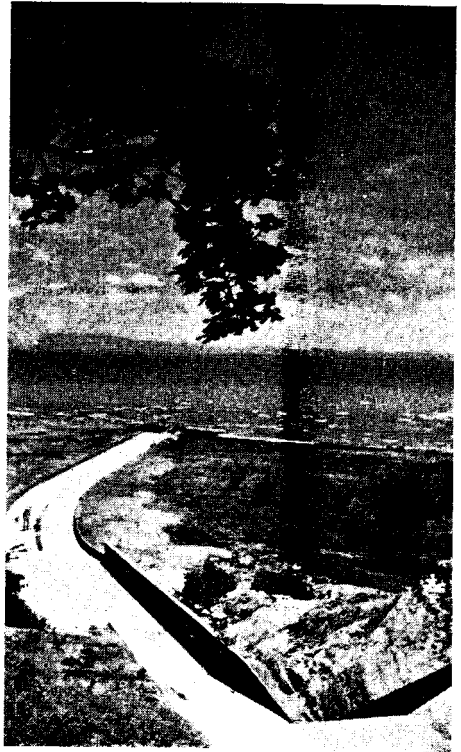
FIG. 4. Terminal spillway and chute.
