THE HOUSE OF THE SCOTCH PAISANO

Archaeological Investigations at the Hugo Reid Adobe, Arcadia, California

WILLIAM J. WALLACE, ROGER J. DESAUTELS, GEORGE KRITZMAN

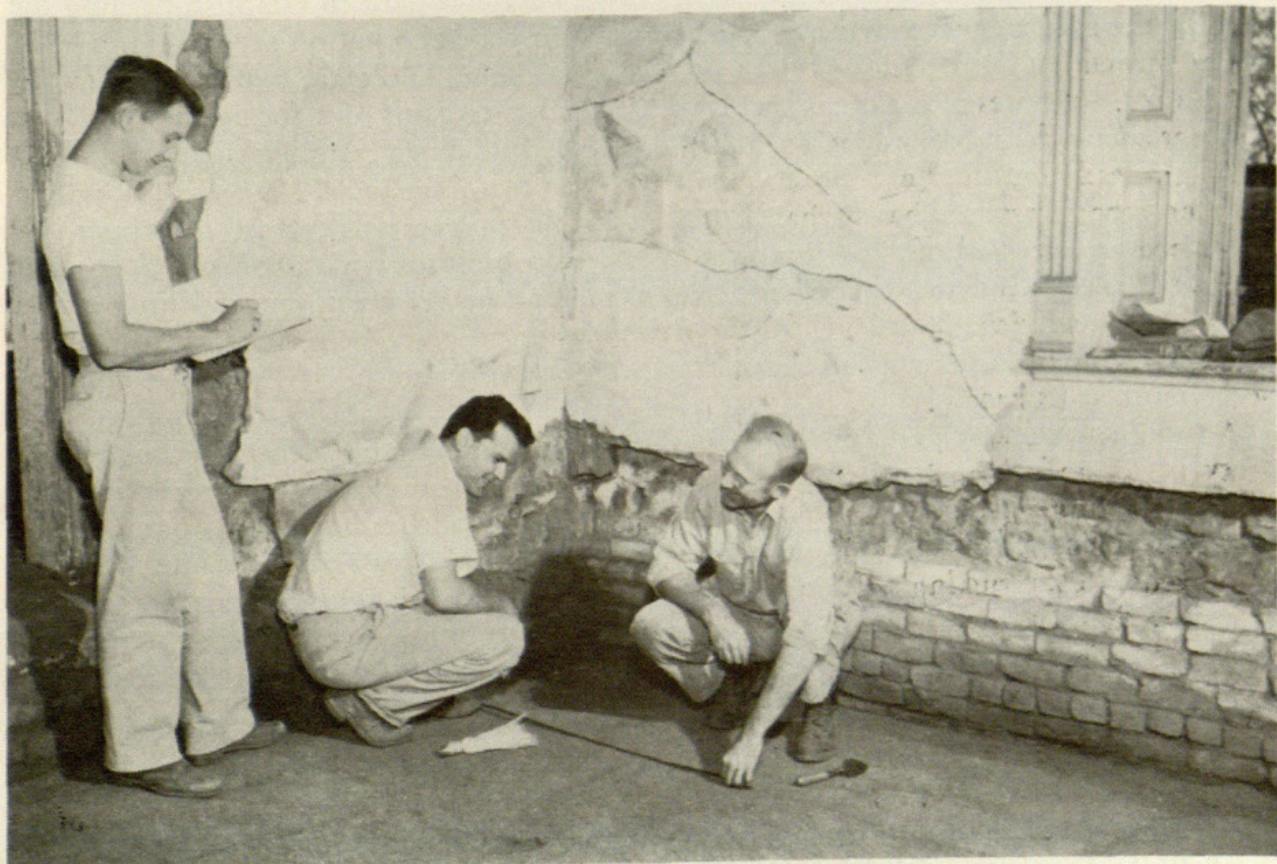
Dr. Wallace (right) is assisted by Mr. Desautels in obtaining the dimensions of the adobe brick floor in Room 3. Mr. Kritzman records their measurements.

Dimensions: north-south, 16 feet 2½ inches; east-west, 16 feet 3¾ inches. An unusual feature here is the flooring. The entire room is paved with evenly-laid, close-fitting adobe blocks. Those adjacent to the walls have been carefully cut to assure a tight fit.

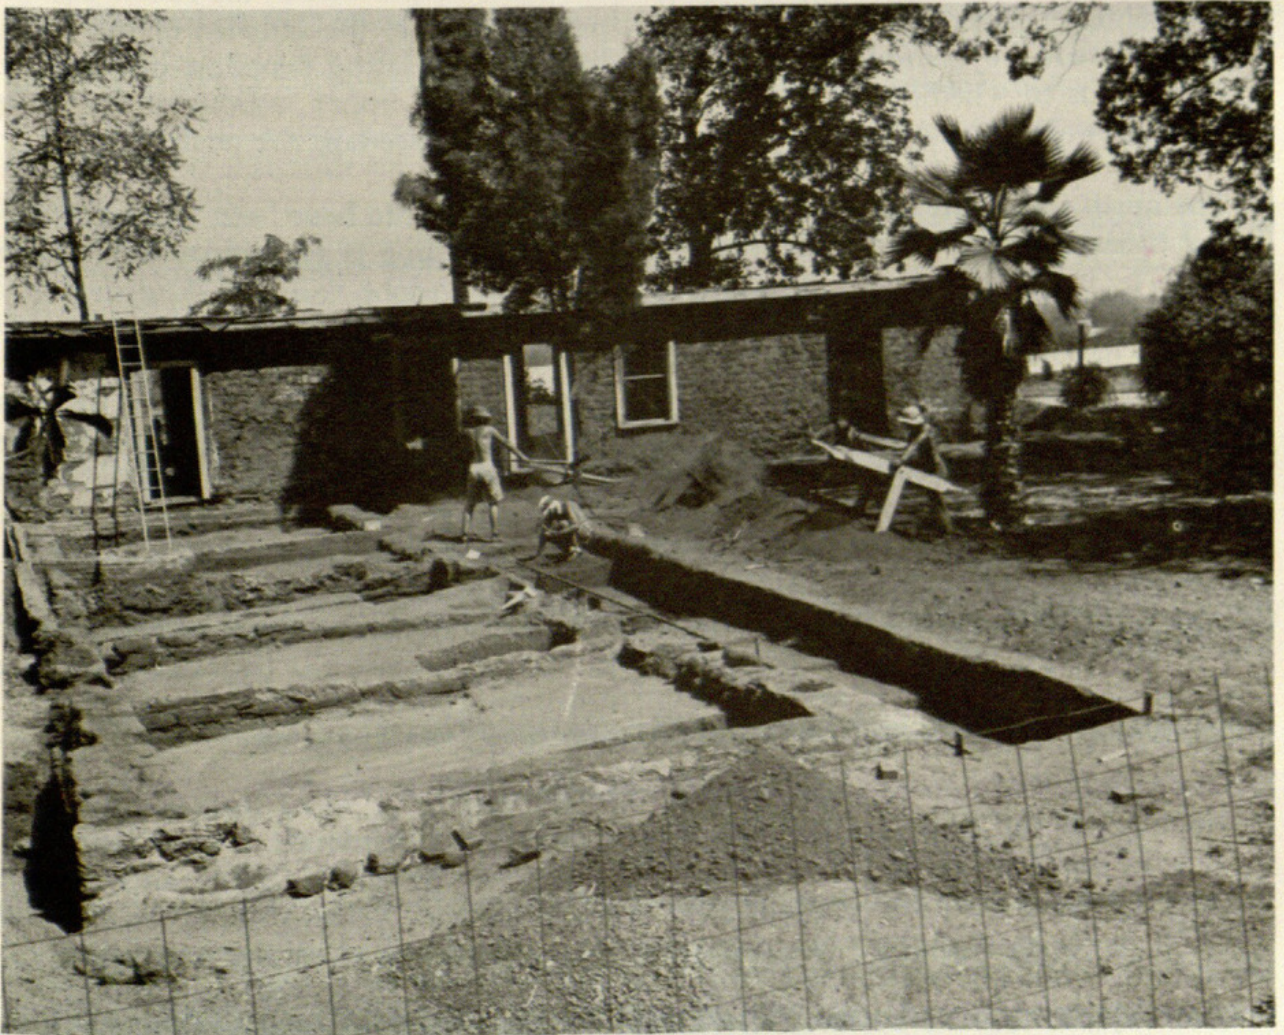
Hugo Reid Adobe and Foundation under Baldwin Annex. Looking east: Ken Dampf shovels out back dirt; Dr. Wallace cleans about pipe in pit; Gary Coon searches rocker screen.
