## THE VALUE OF HISTORICAL RECORDS: THE WARRNAMBOOL EARTHQUAKE OF JULY 1903

By K. F. McCUE\*

**ABSTRACT:** Historical information drawn mainly from old newspapers was examined to draw up a representative isoseismal map of the larger of the two earthquakes at Warrnambool, Victoria, in 1903. This occurred on July 14. The map was used as a basis for locating the earthquake's epicentre and magnitude. The damage and notable secondary effects such as liquefaction are discussed, in an effort to draw the attention of town planners, engineers and architects to the possible consequences of building in areas of even minor seismicity.

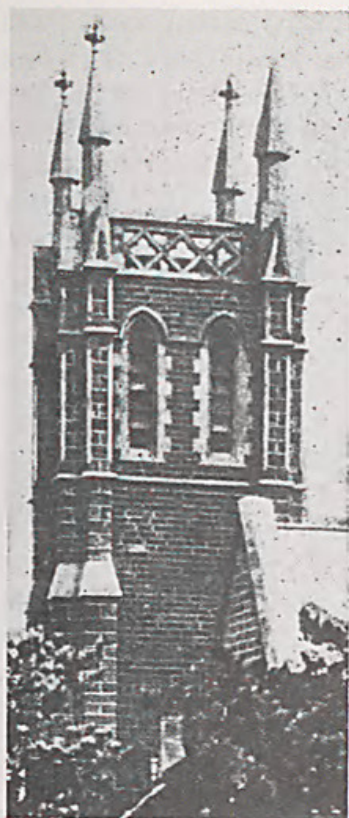
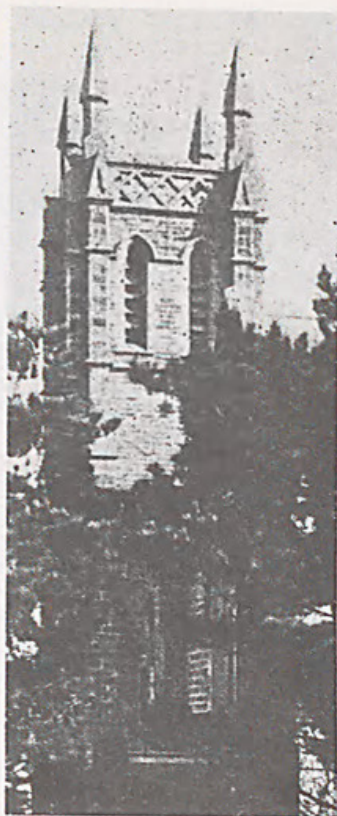
PLATE 18

(Above) Presbyterian Church after the first (April) and second (July) shocks. Note the crosses.

involved fallen plaster from cornices, ceilings and walls, dislodged or fallen ornaments such as balustrades, or church crosses weighing up to 2½ cwt. (see Pl. 18, above) and collapsed chimneys. Many walls were cracked (see Pl. 18, below) and in the two buildings declared unsafe for habitation whole sections of the wall had fallen out.

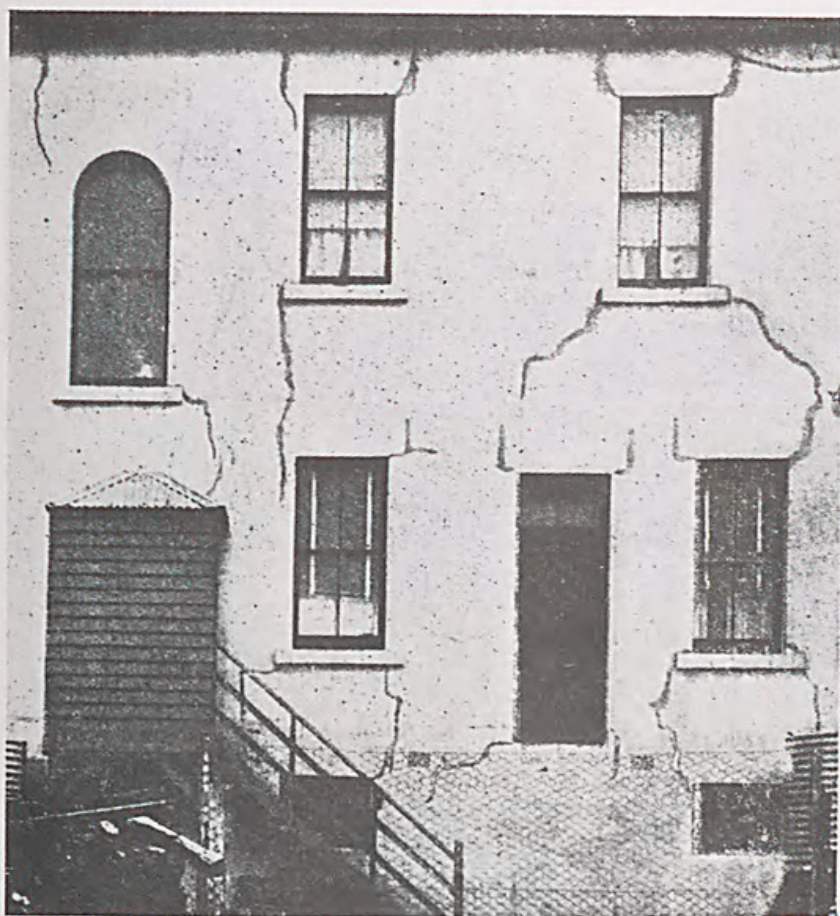
(Below) Cracks at the back of the Brian Boru Hotel which reflect the stress concentration at the openings. (Both photographs from the *Warrnambool 'Standard'*.)

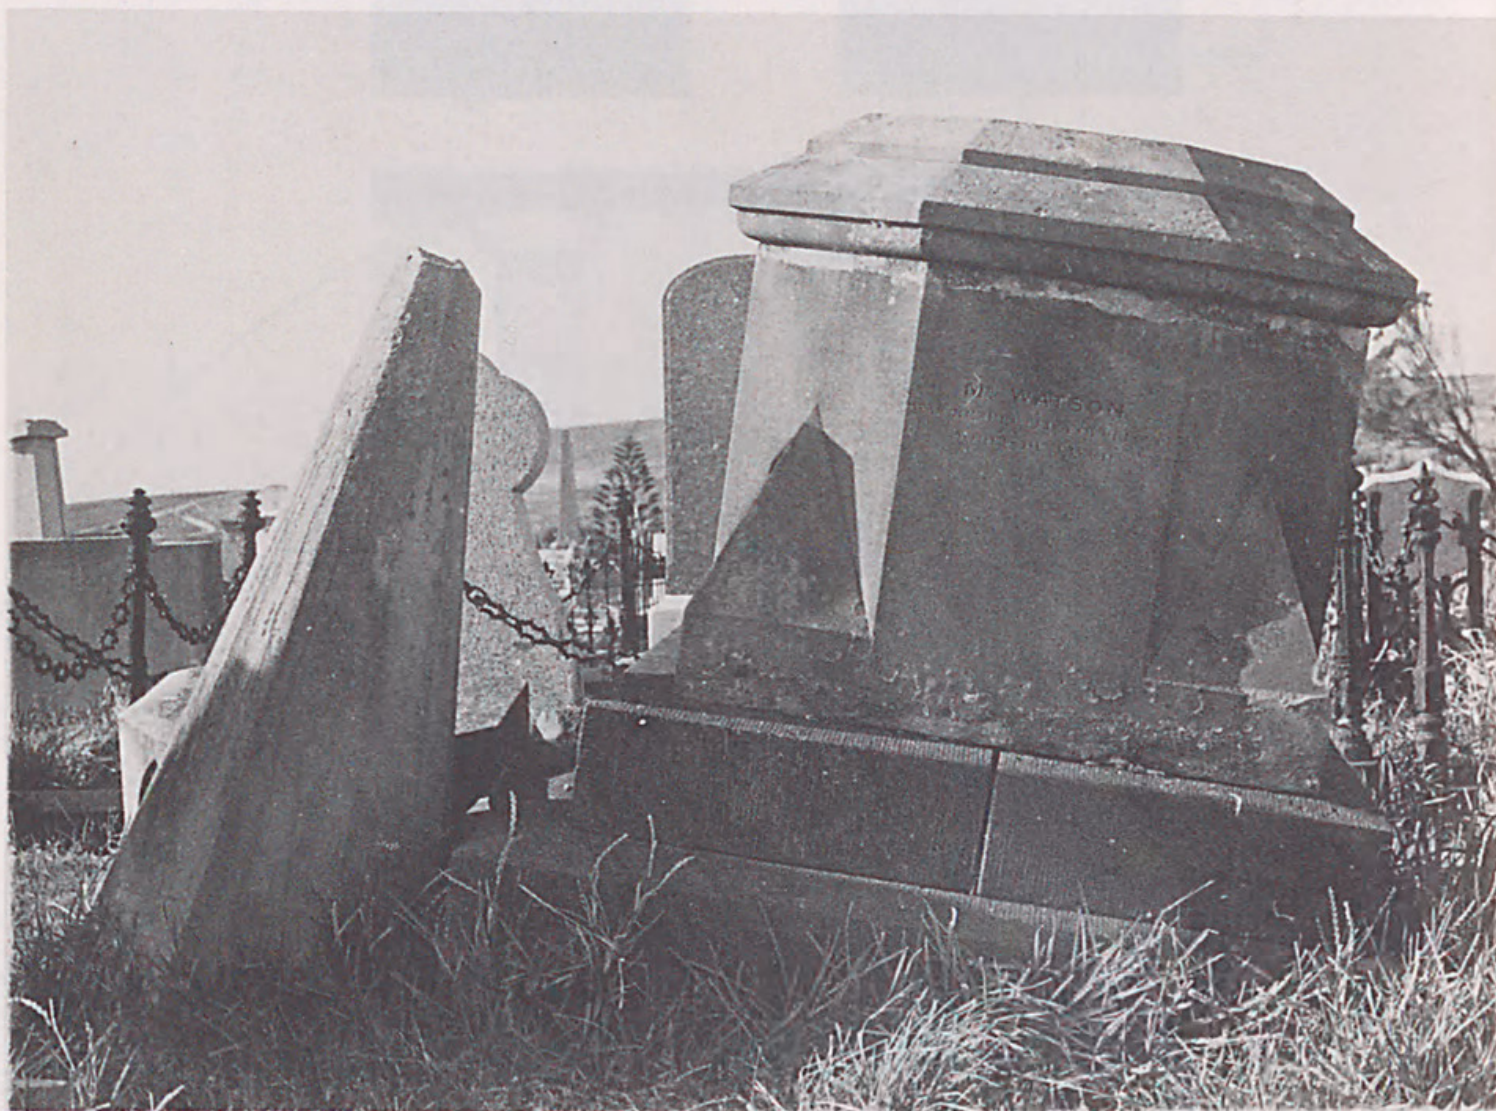
PLATE 19

Tombstone shifted in the Warrnambool Cemetery. (Photograph from the Warrnambool 'Standard'.)

In the cemetery, tombstones were shifted, many twisted, and some columns and headstones had fallen or sheared off at the base (see Plates 19, 20). The more severe damage in the July than in the April event may have been in part the result of cumulative effects of the two earthquakes. Cracks from the first earthquake were found to have been re-opened or widened by the second.

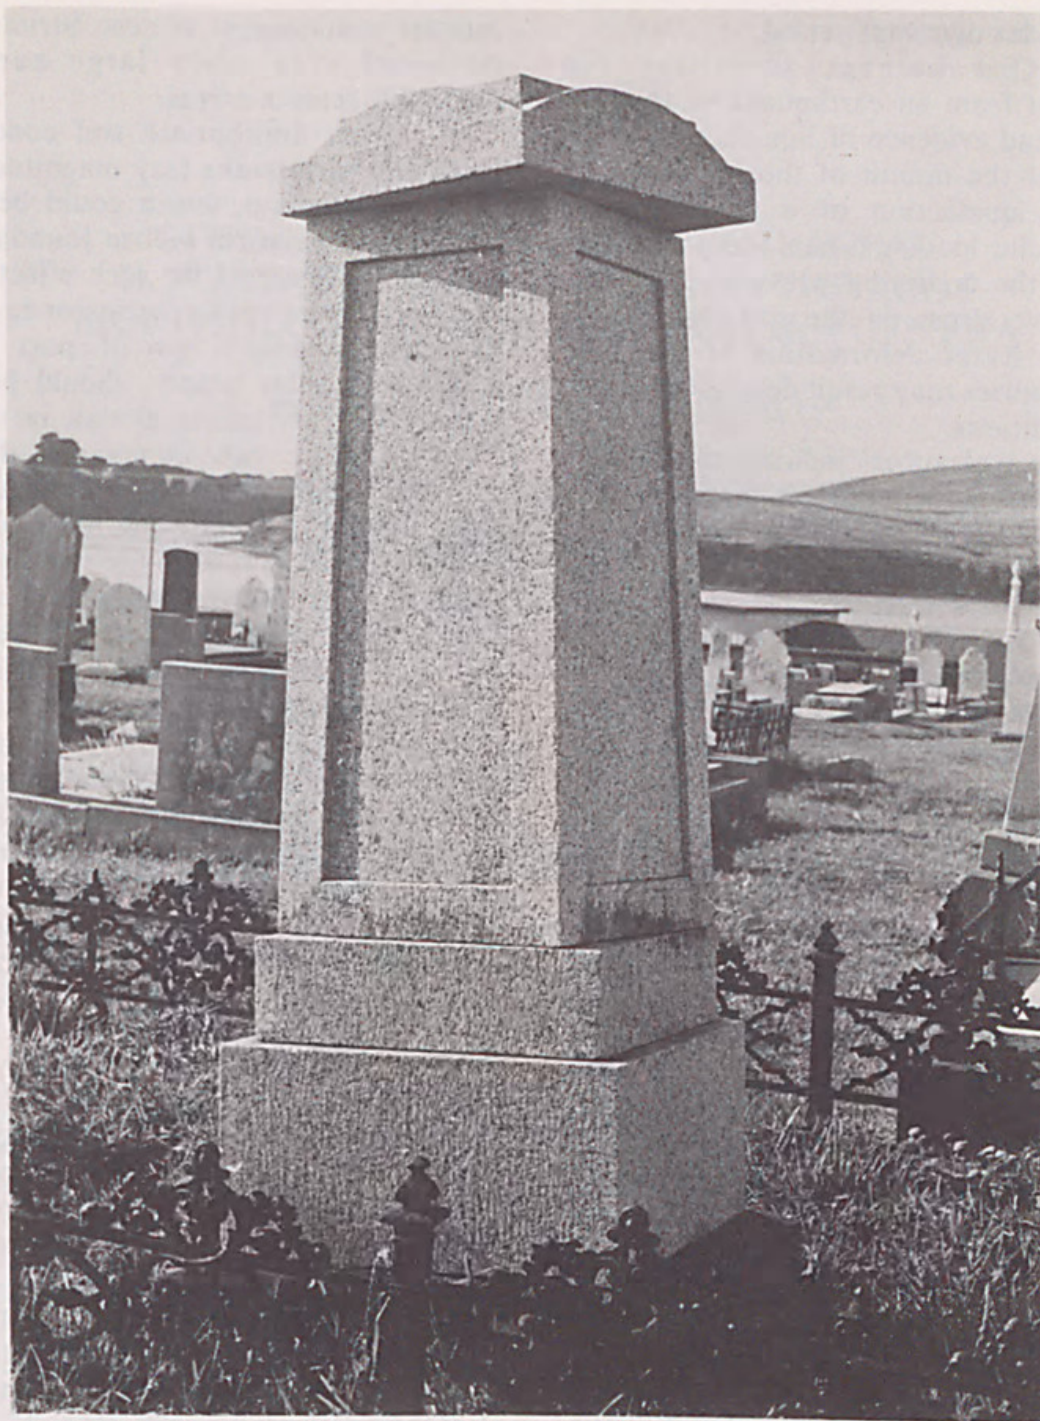
PLATE 20

Tombstone in the Warrnambool Cemetery rotated. Note displacement of top. (*Photograph from the Warrnambool 'Standard'.*)
