# JOURNAL OF THE EAST AFRICA NATURAL HISTORY SOCIETY AND NATIONAL MUSEUM

Volume 81, Number 197

## NATURAL INDICATORS OF SHALLOW GROUND WATER IN KIBWEZI DIVISION, KENYA

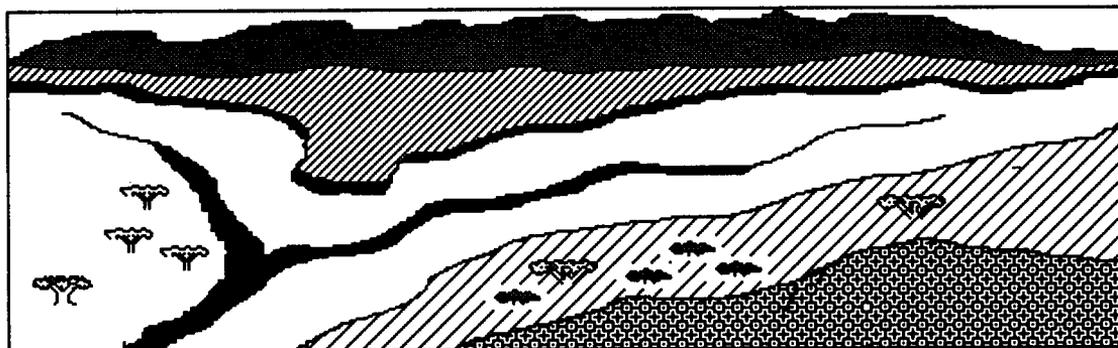
**Positive signs**

Presence of *A. robusta*  
*A. gerrardii*  
*A. xanthophloea*

Near to a river bed  
 Within 2 km of lava belt

**Likely signs**

Near to a dam  
 Green cover in dry season

**Negative signs**

Basement outcrops  
 On high ground  
 Sandy/Quartz rich soils  
 Presence of *A. mellifera*

Figure 5. Summary of natural indicators for detecting shallow ground water in Kibwezi
