ANALYSIS OF A TIDAL DITCH AND ITS CROSSINGS

LEON DALENCOUR, Civil and Sanitary Engineer
Port-au-Prince, Haiti

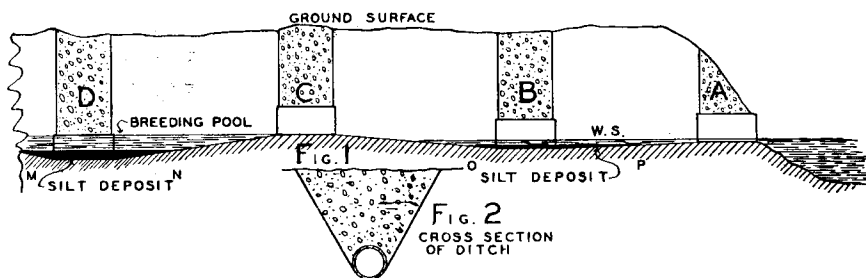
These pipes are laid at varying depths, and no particular care has been taken concerning their level with reference to the outlet pipe "A" as shown in Fig. 1.

During an extreme low-tide period, when the highest water level reaches the line W.S. in Fig. 1, which coincides with the *bottom* level of pipe "A," ditch breeding occurred.

Silting took place between pipes A and C, and so on up ditch from every pipe that was higher than the ditch above it. See Fig. 1.

Breeding took place in pools thus formed by the high points in the ditch.

water surface may reach the line W.S. and above as shown in Fig. 3.

The silting which may occur rapidly in a rainy season can become as important as indicated by the black area of Fig. 3.

The ditch ceases to function as a result of the complete obstruction of the pipe, producing a prolific breeding basin above this point.

Pipe B is almost completely filled, causing the lowering of the salinity of the water between pipe B and the pass-over at D.

1. The bottom line of all pipes laid in a tidal ditch should be level with the outlet.
2. A pipe of which the bottom level is higher than the bottom of the ditch above, or lower than the outlet, is a failure from the standpoint of eradicating mosquito breeding places.
